TG Project Management

Infrared Inspection Report

234 Main St., Newark, NJ 07654
Inspection prepared for: Al Smith & Maria Smith
Date of Inspection: 4/28/2015 Time: 11 am
Age of Home: 45 years +/- Size: 1400 SF.
Weather: Sunny

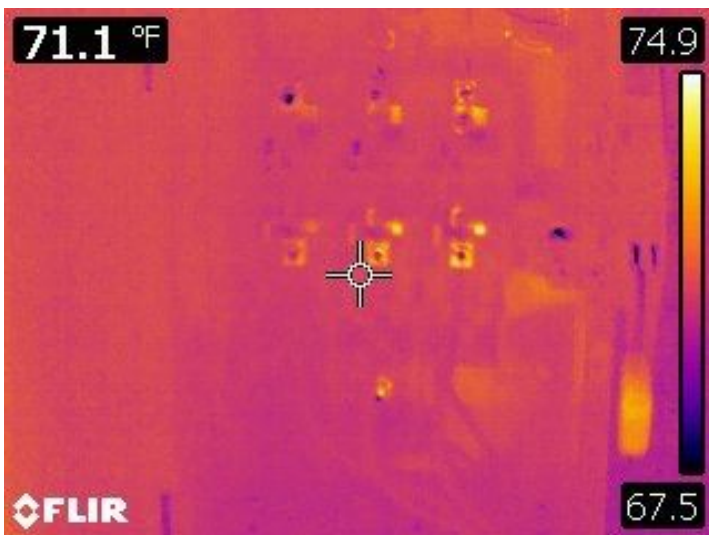
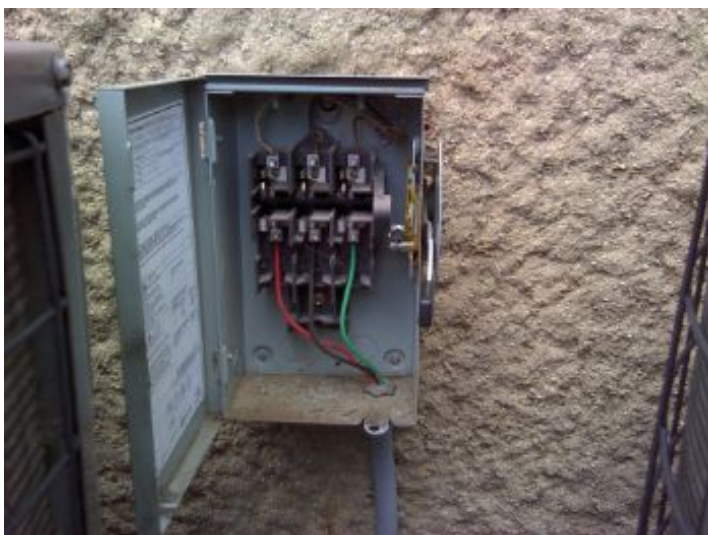
Condenssor disconnect

Observations:
 • Freon leak in copper supply line

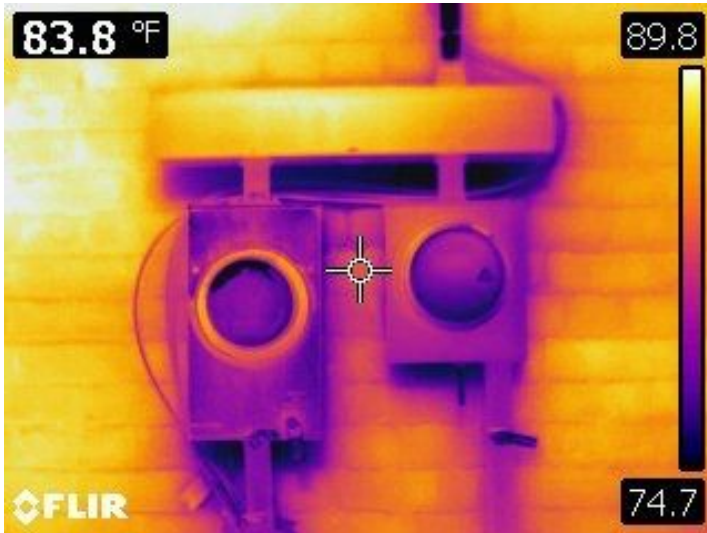
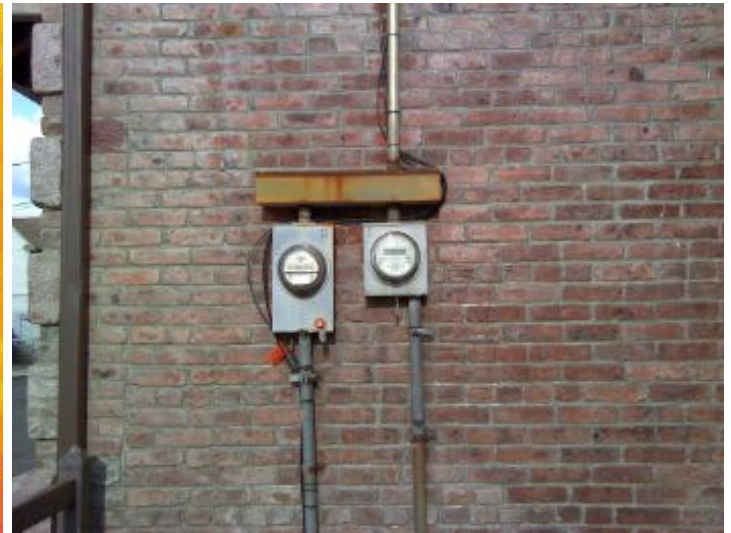
Meter pans

Observations:
 • Outlets are overheating & we recommend a license electrician to test device

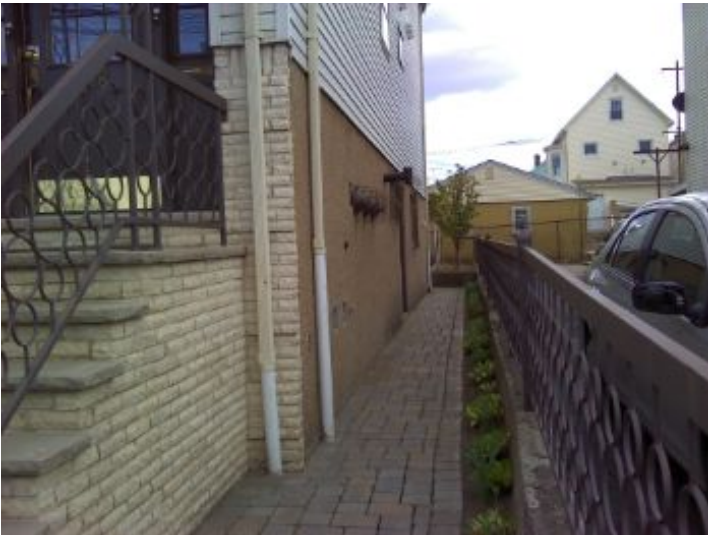
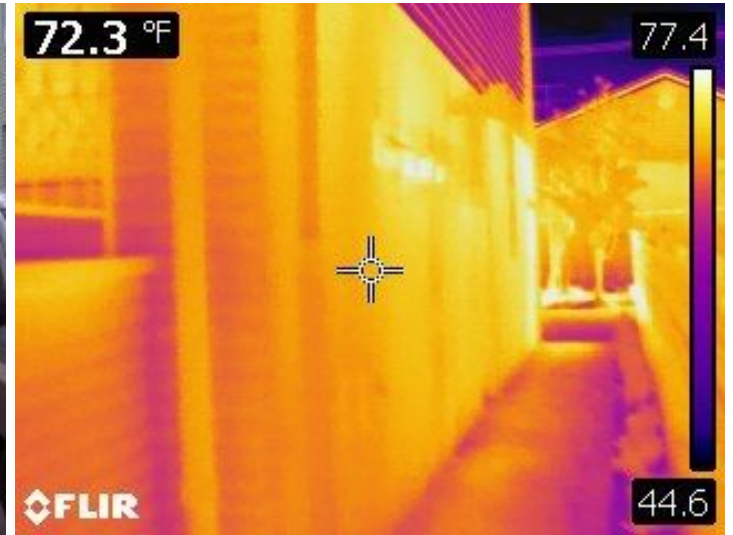
S. elevation

- No insulation in foundation wall

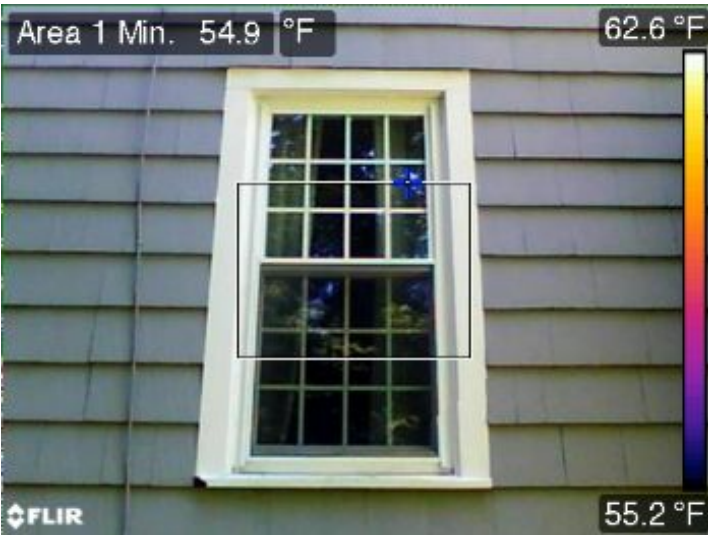
- Window leaks air on all sides

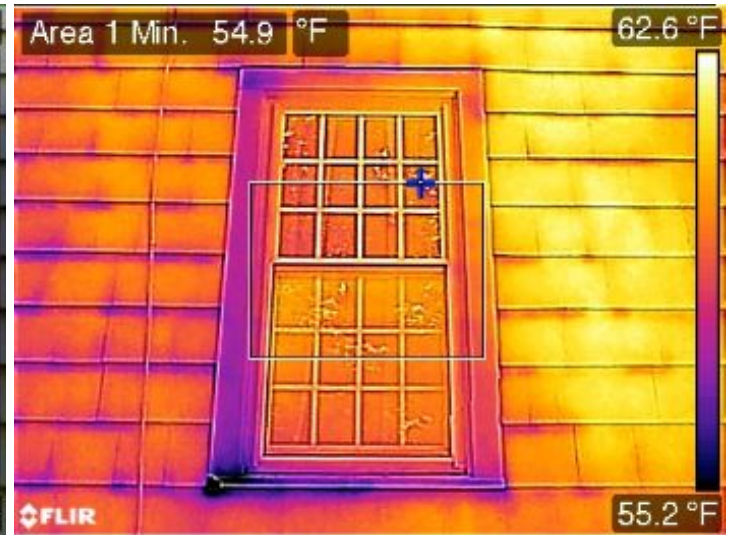
Draft seen in window

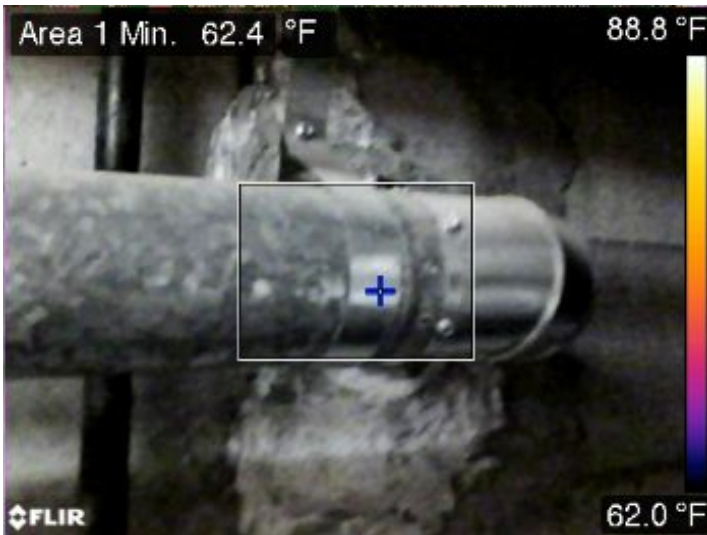
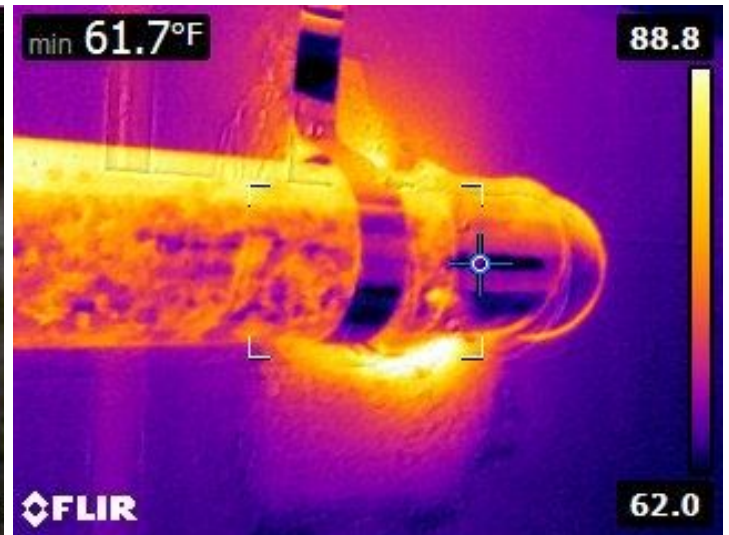
Hot water pipe

Observations:
 • Water leaks detected

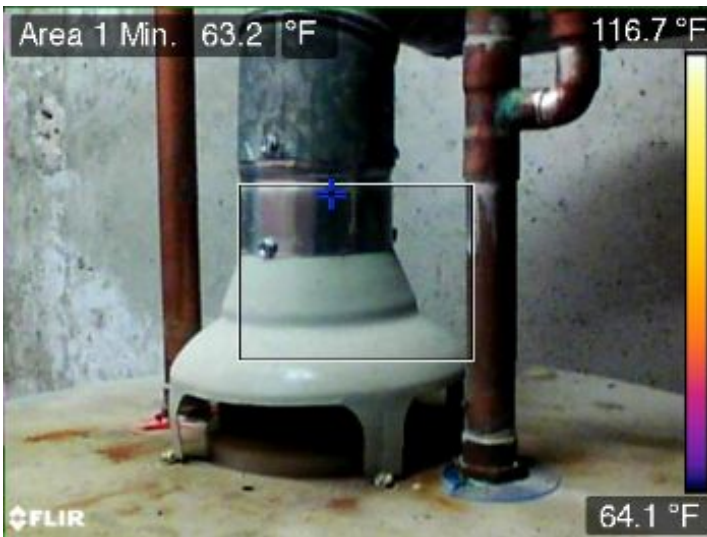
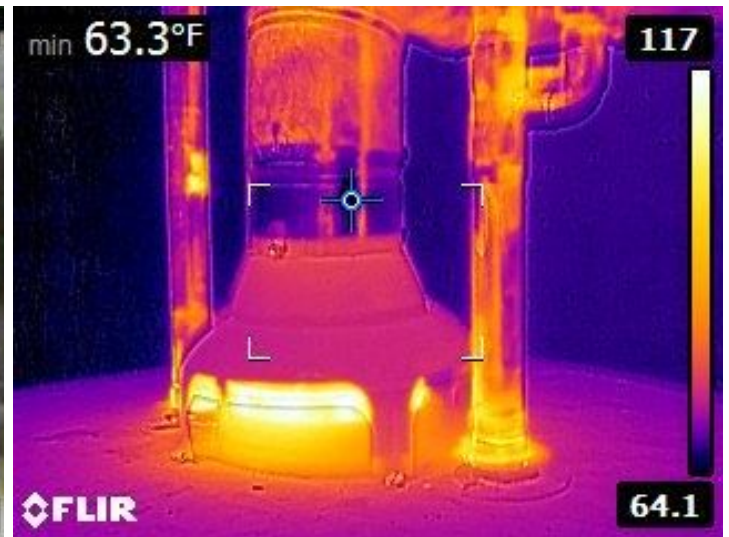
Hot water tank

Observations:
• Water damage/leaks detected recommend service

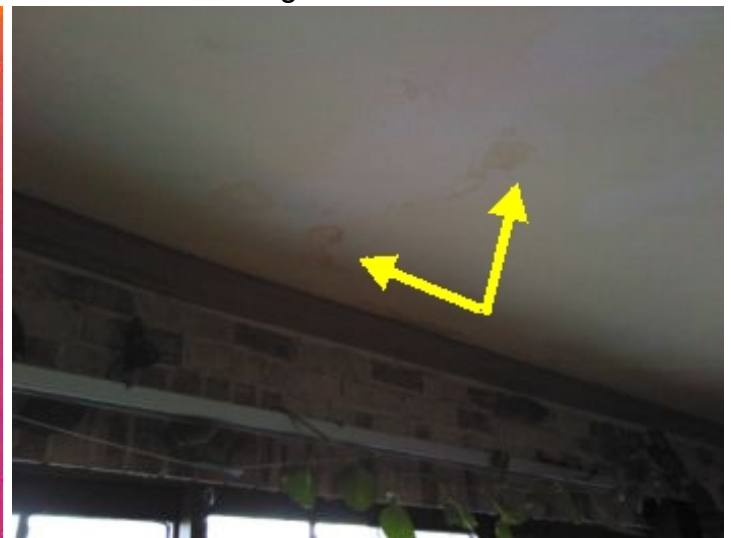
Observations:
• Wet / spotted patches in ceiling

Water stains

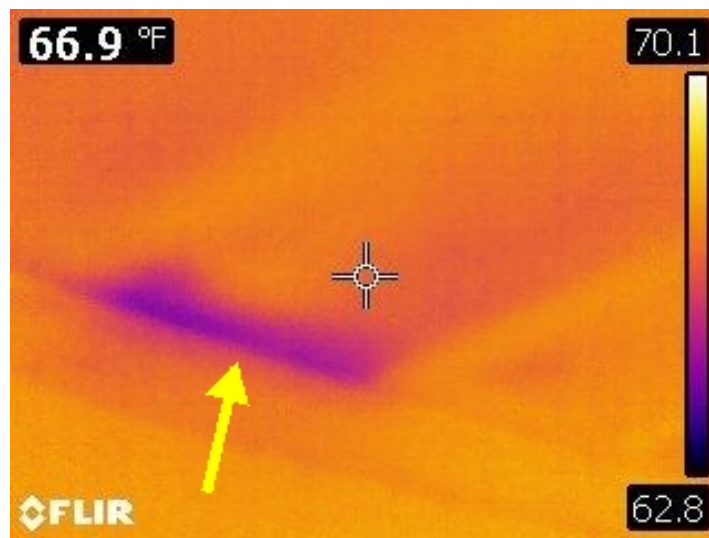
water damage & possible mold

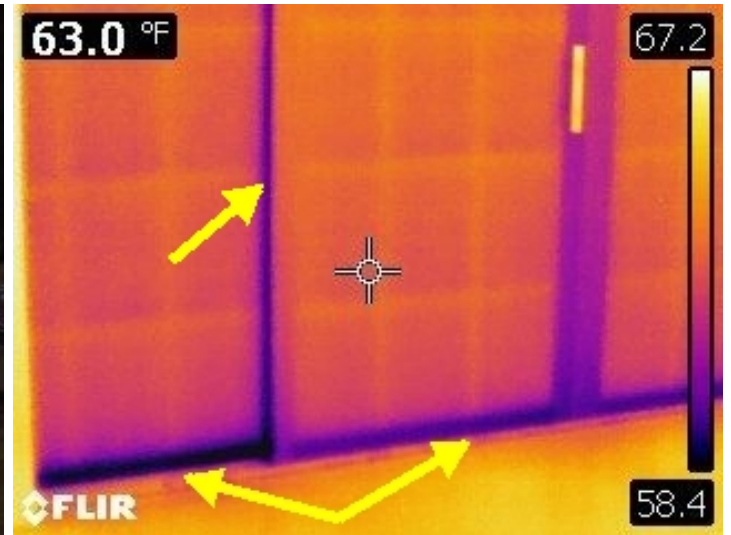
- Air filtration noted

Porch sliding door air filtration

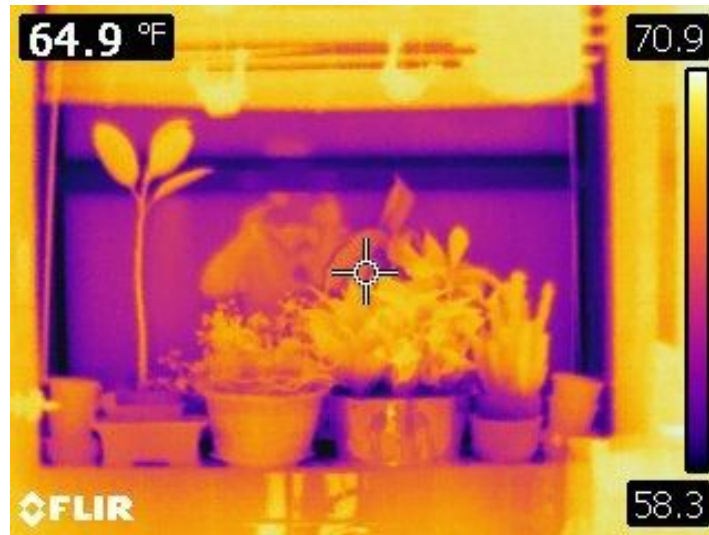
- Air filtration noted

air filtration
