Infrared Inspection Report

234 Main St., Newark, NJ 07654
Inspection prepared for: Al Smith & Maria Smith
Date of Inspection: 4/28/2015 Time: 11 am
Age of Home: 45 years +/- Size: 1400 SF.
Weather: Sunny

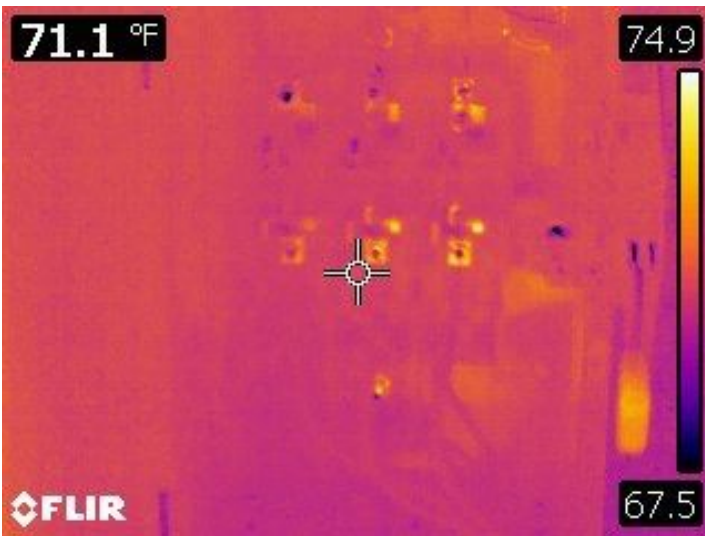
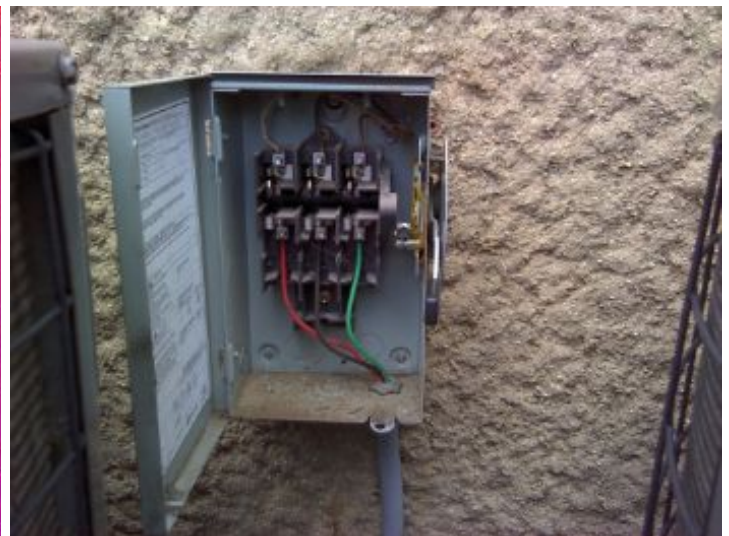
Condenssor disconnect

Observations:
 • Freon leak in copper supply line

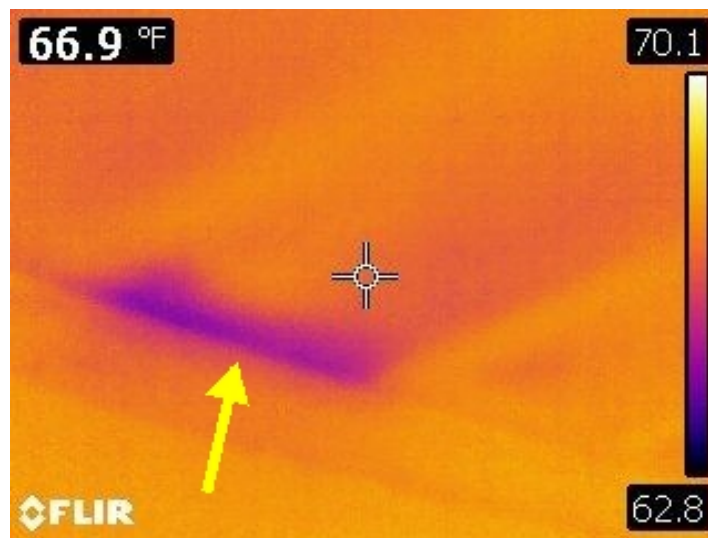
Observations:
• Wet / spotted patches in ceiling

water damage & possible mold
